**TRANSPORTATION SCIENCES
CRASH DATA RESEARCH CENTER**

**CALSPAN ON-SITE AIR BAG RELATED CHILD FATALITY INVESTIGATION
CALSPAN CASE NO. CA96-010
VEHICLE - 1996 DODGE CARAVAN SE
LOCATION - TENNESSEE
CRASH DATE - 1996**

1. Report No. CA96-010	2. Government Accession No.	3. Recipient's Catalog No.	
4. Title and Subtitle Calspan On-Site Air Bag Related Child Fatality Investigation Vehicle - 1996 Dodge Caravan SE Location - State of Tennessee		5. Report Date: --

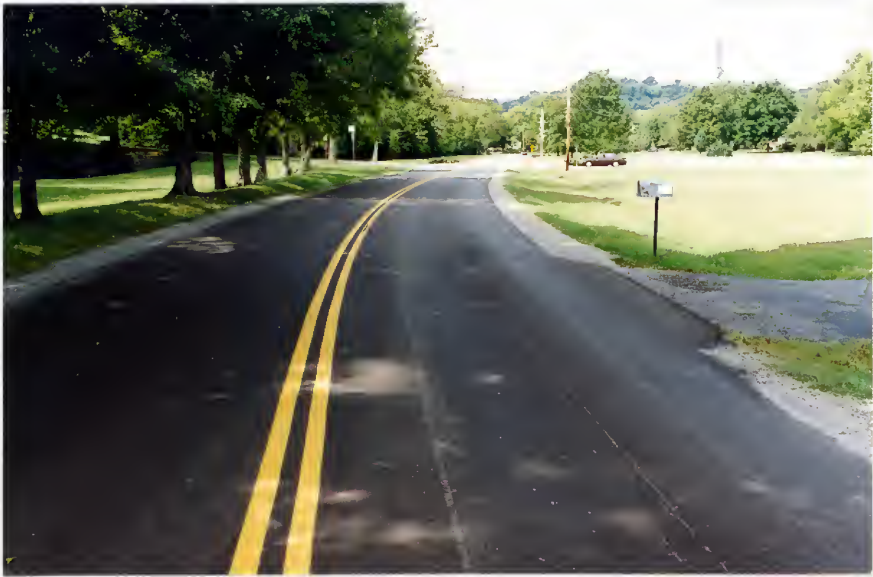
1. Northbound view of the Dodge Caravan's initial approach to the crash scene.

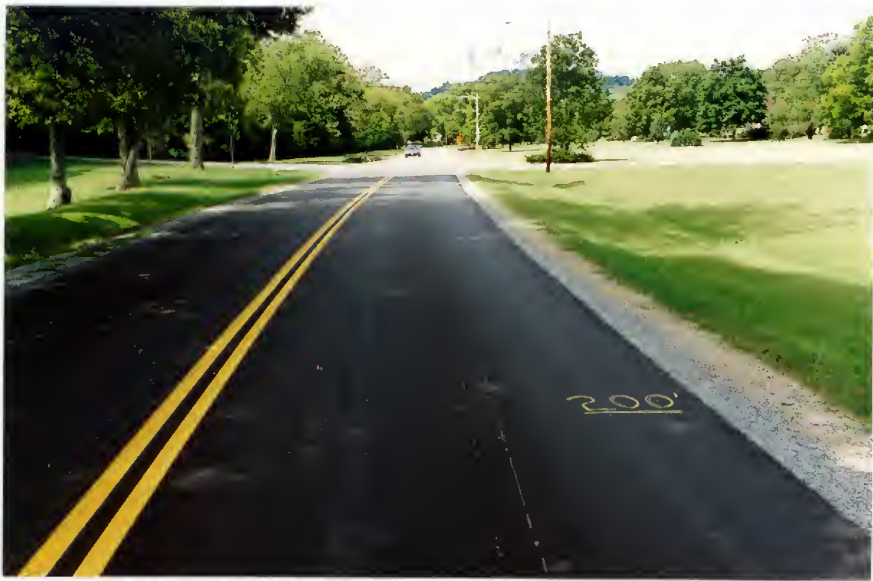
2. Dodge Caravan's approach view at 61 meters (200 feet) from point of impact (POI).

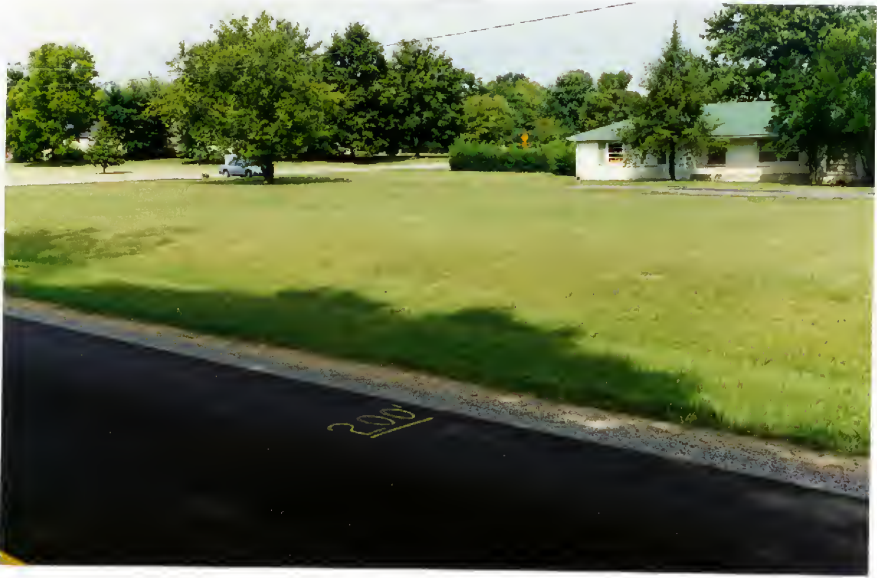
3. Dodge Caravan's view of Mercury Cougar's approach path at 61 meters (200 feet).

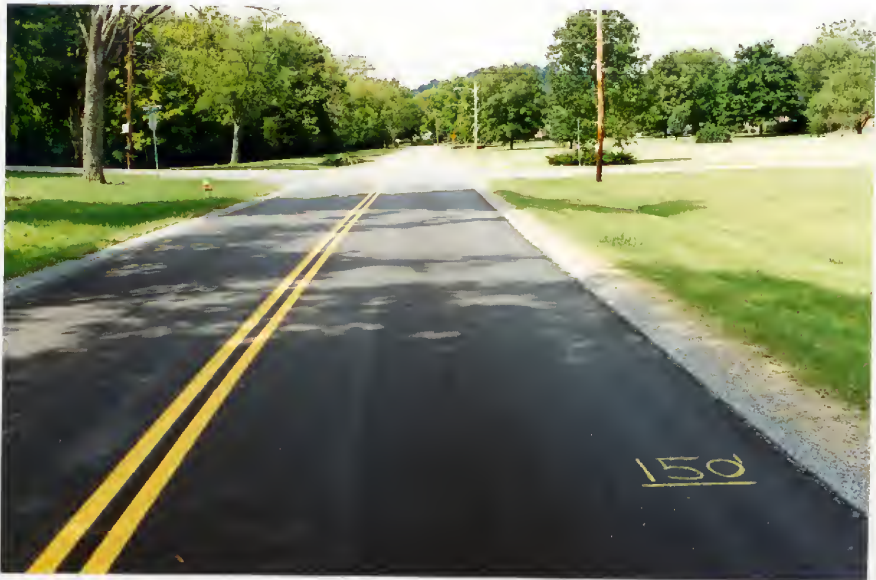
4. Dodge Caravan's approach view at 46 meters (150 feet) from the POL..

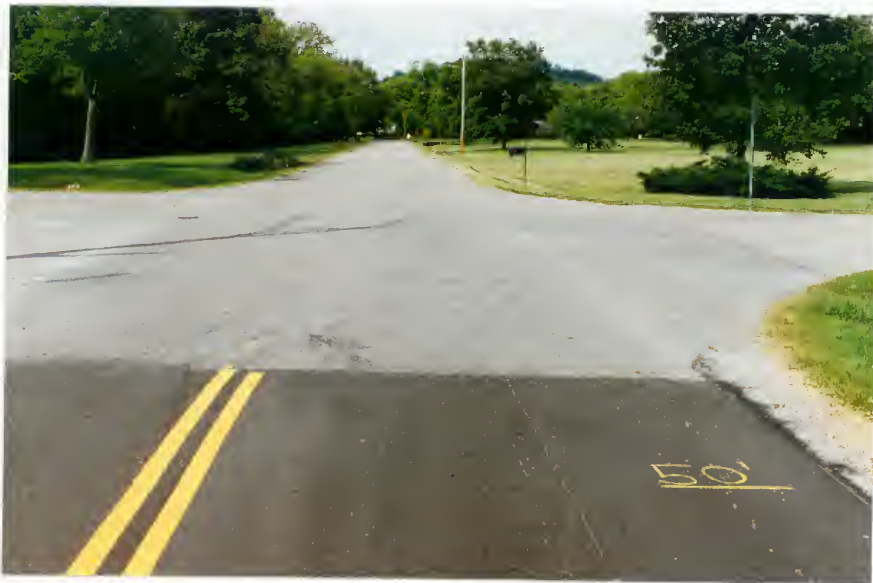
7. Dodge Caravan's approach view at 15 meters (50 feet) from crash impact point.

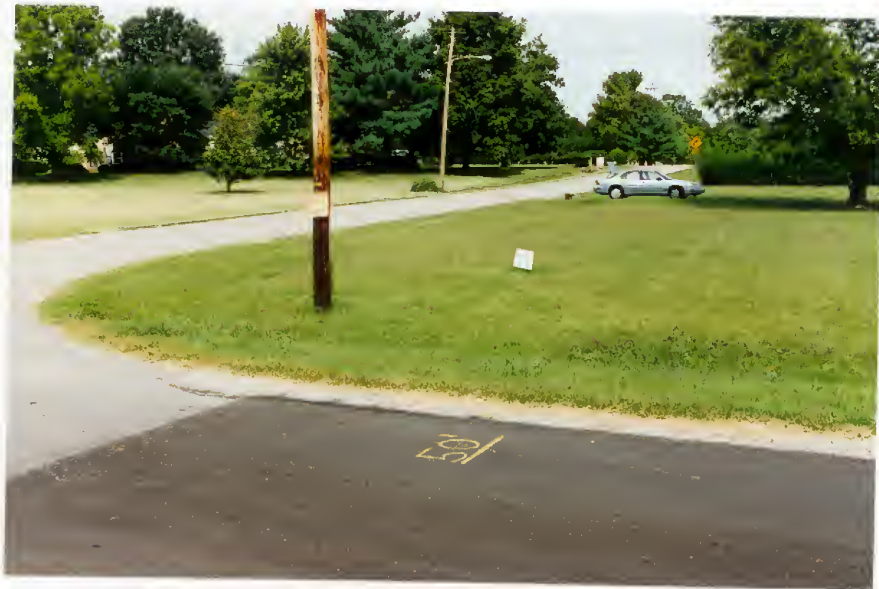
8. Dodge Caravan's view of Mercury Cougar's approach path at 15 meters (50 feet).

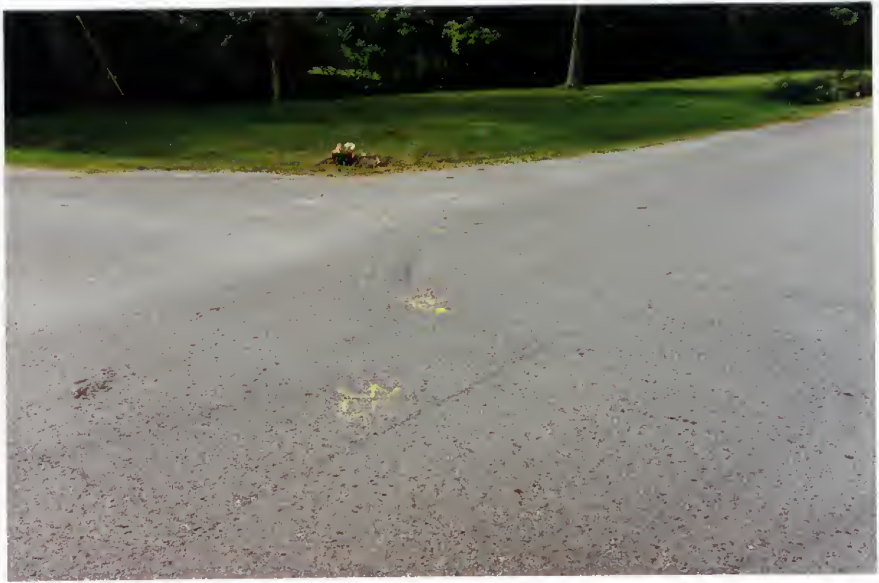
9. View of the POI.

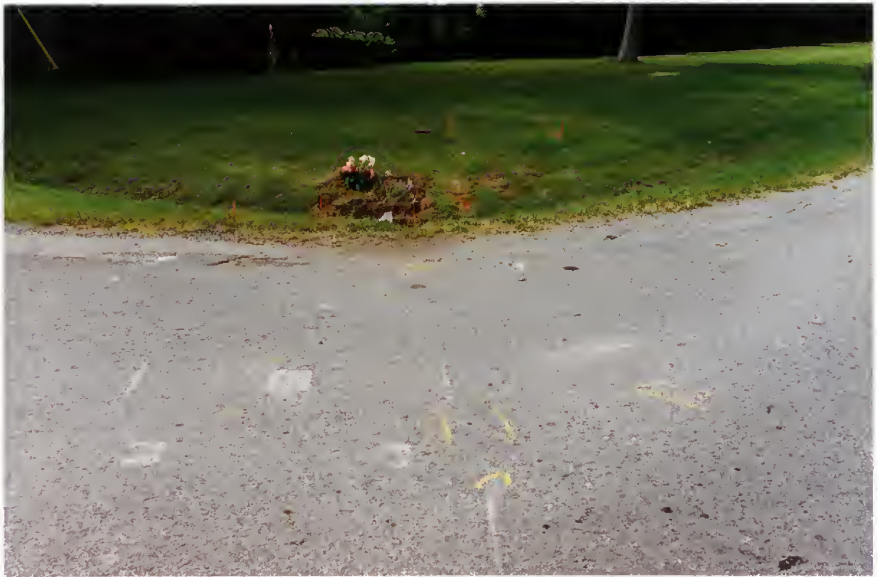
10. Post impact trajectory of the Dodge Caravan.

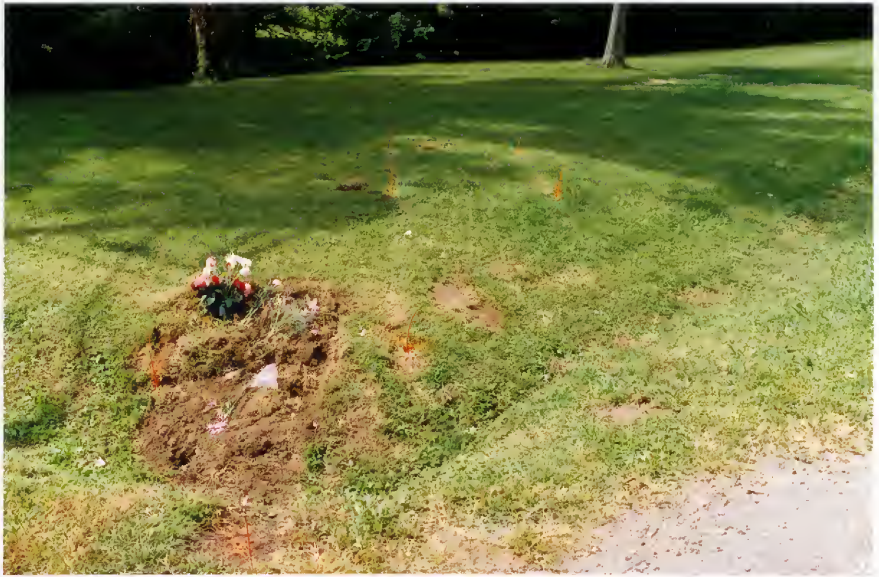
11. View of final rest position of Dodge Caravan and Mercury Cougar.

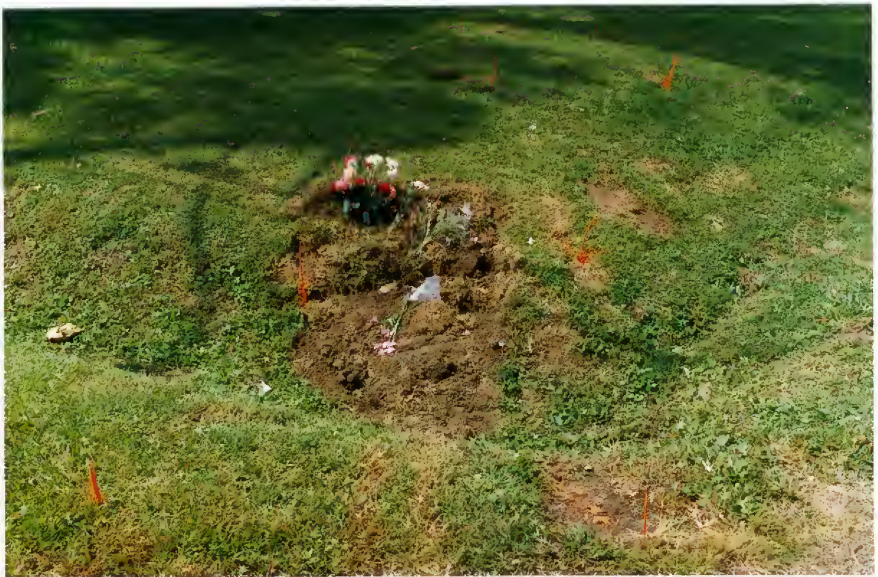
12. View of the embankment impacted by the front of the Dodge.

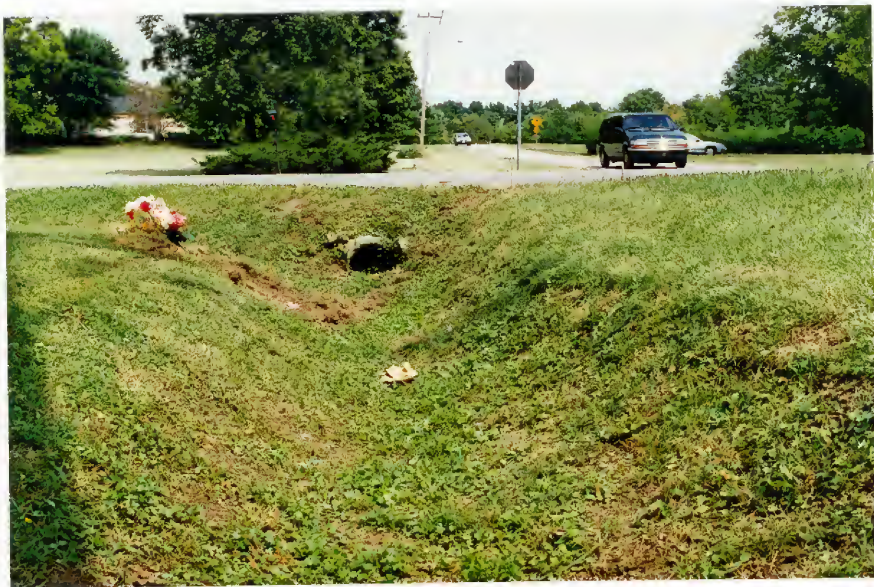
13. Westward view along the ditch line.

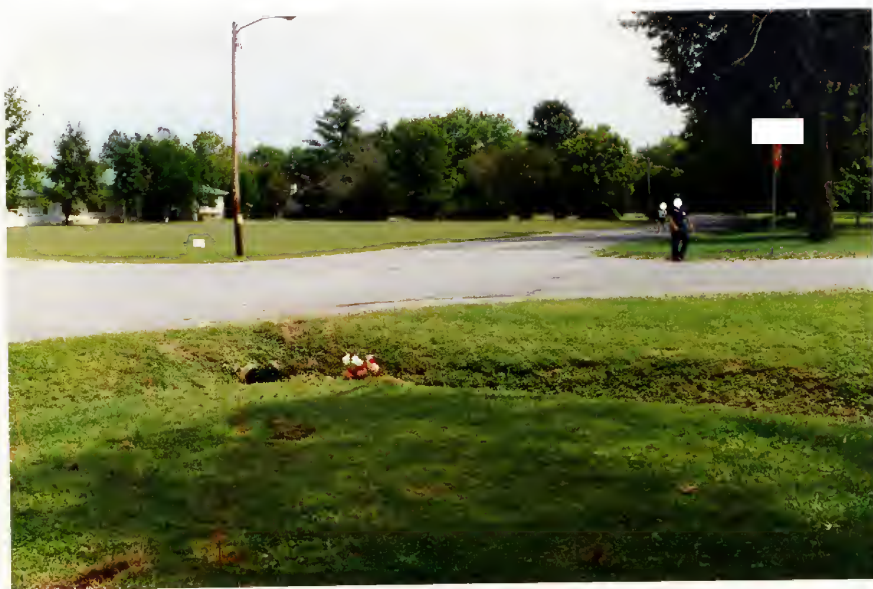
14. Look back view of from the Dodge Caravan's rest position.

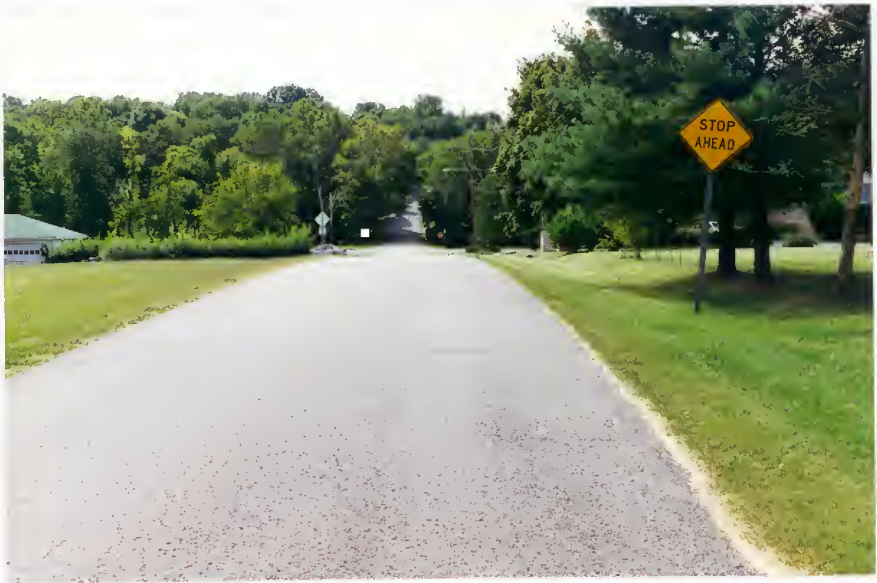
15. View of the Mercury Cougar's approach into the intersection at the hill crest.

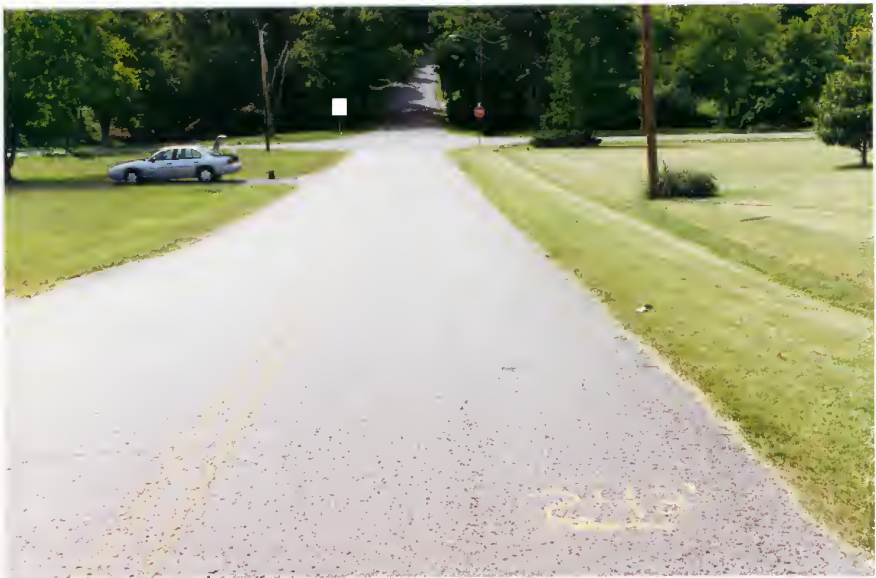
16. Mercury Cougar's approach view at 74 meters (243 feet) from the POI.

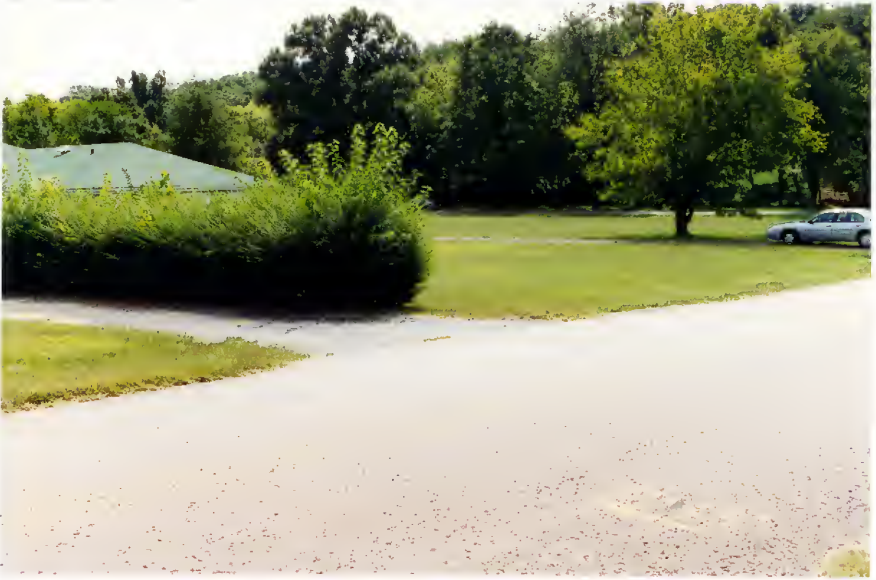
17. Mercury Cougar's view of Dodge Caravan's approach path at 74 meters (243 feet).

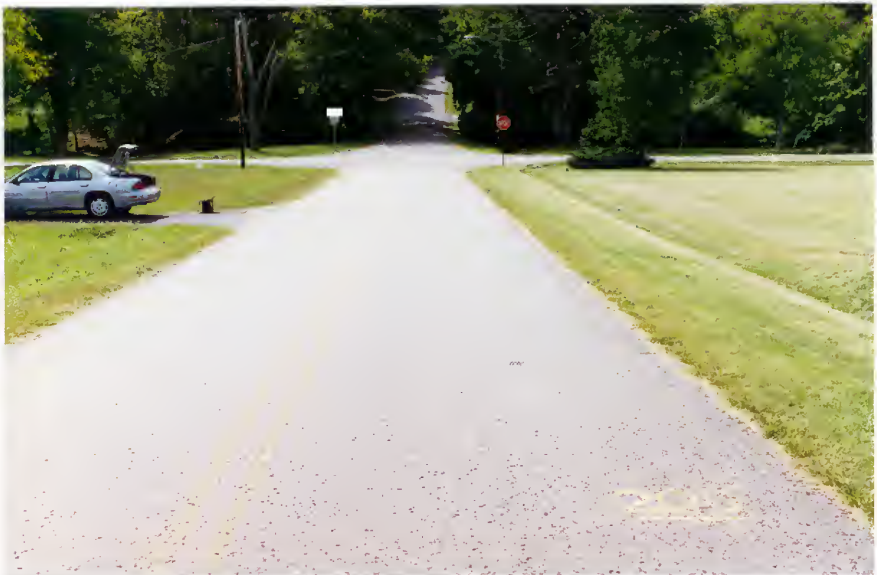
18. Mercury Cougar's approach view at 61 meters (200 feet) from the POI.

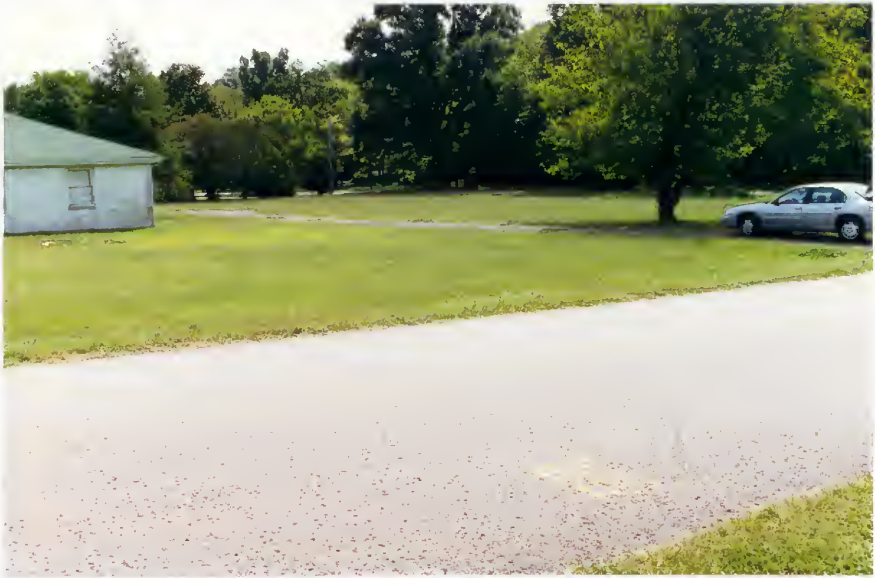
19. Mercury Cougar's view of Dodge Caravan's approach path at 61 meters (200 feet).

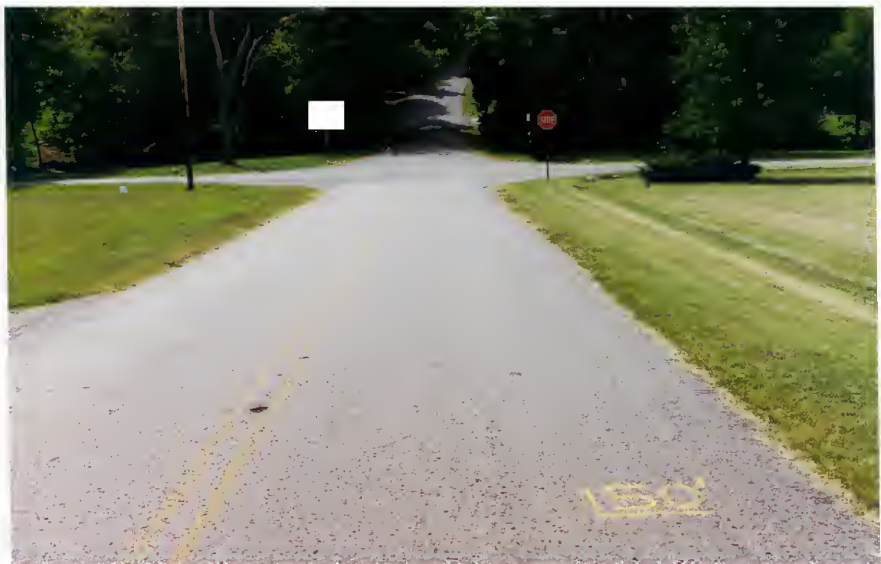
20. Mercury Cougar's approach view at 46 meters (150 feet) from the POI.

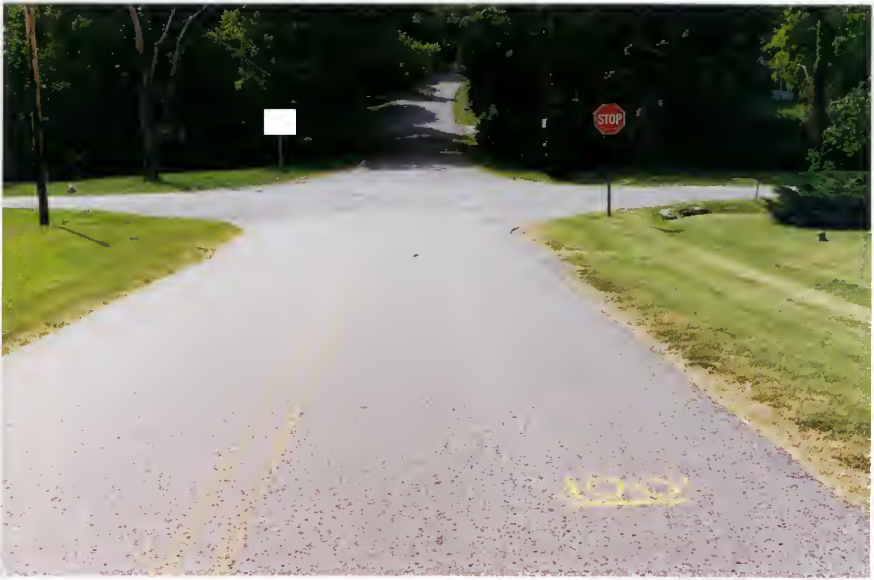
21. Mercury Cougar's approach view at 30 meters (100 feet) from the POI.

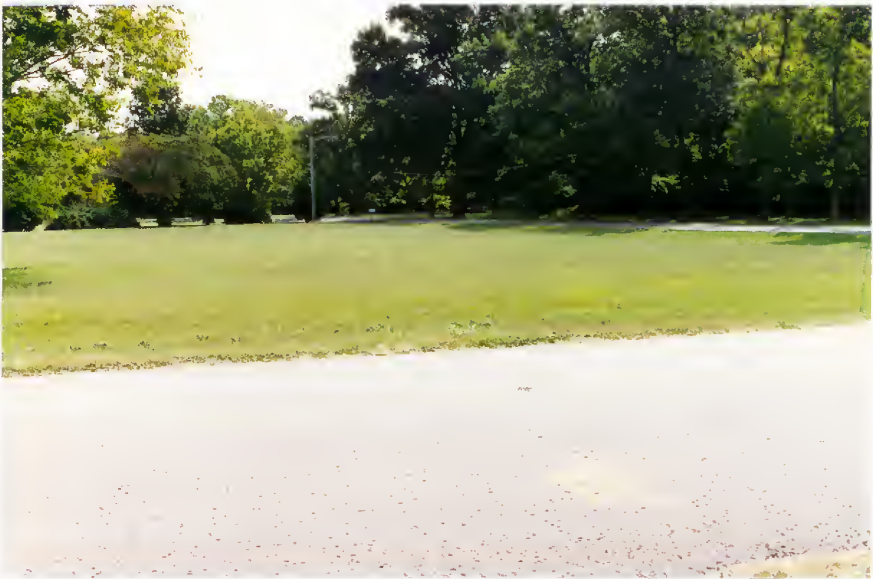
22. Mercury Cougar's view of Dodge Caravan's approach path at 30 meters (100 feet).

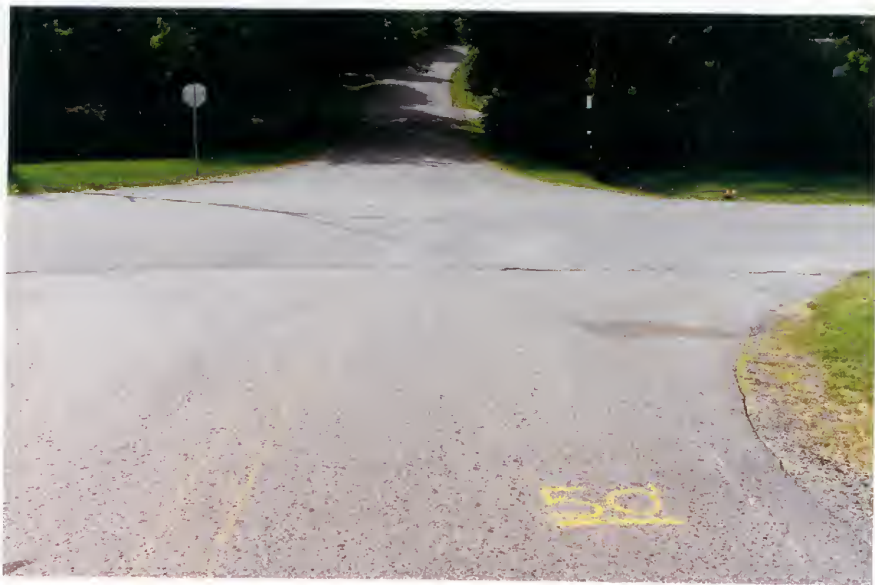
23. Mercury Cougar's approach view at 15 meters (50 feet) from the POI.

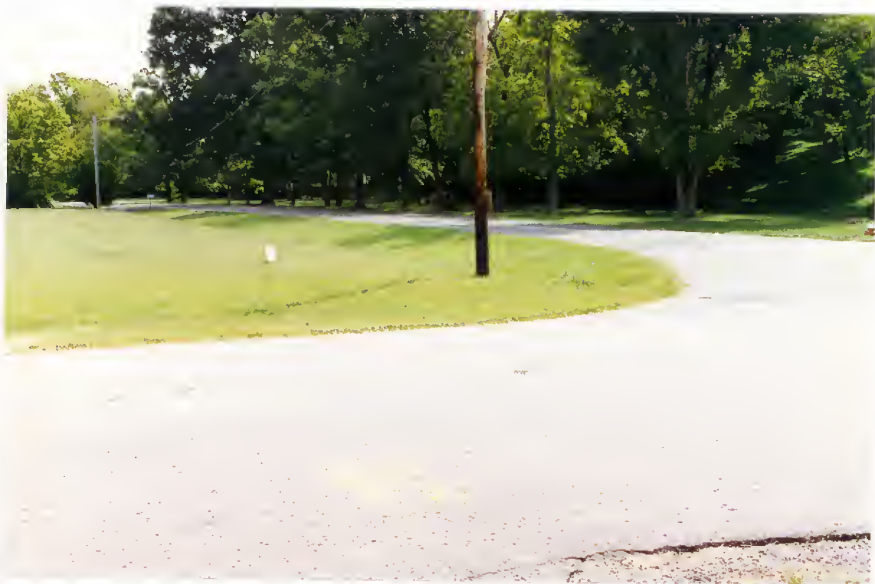
24. Mercury Cougar's view of Dodge Caravan's approach path at 15 meters (50 feet).

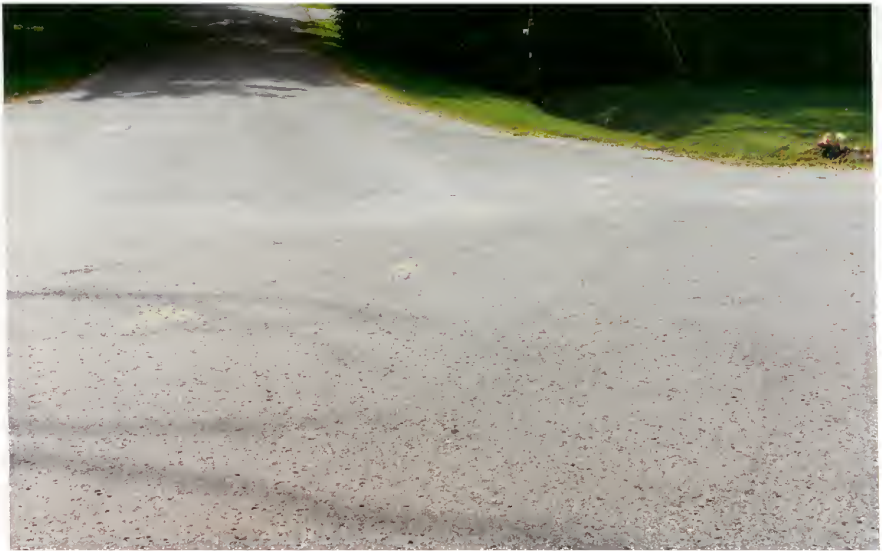
25. View of the POI.

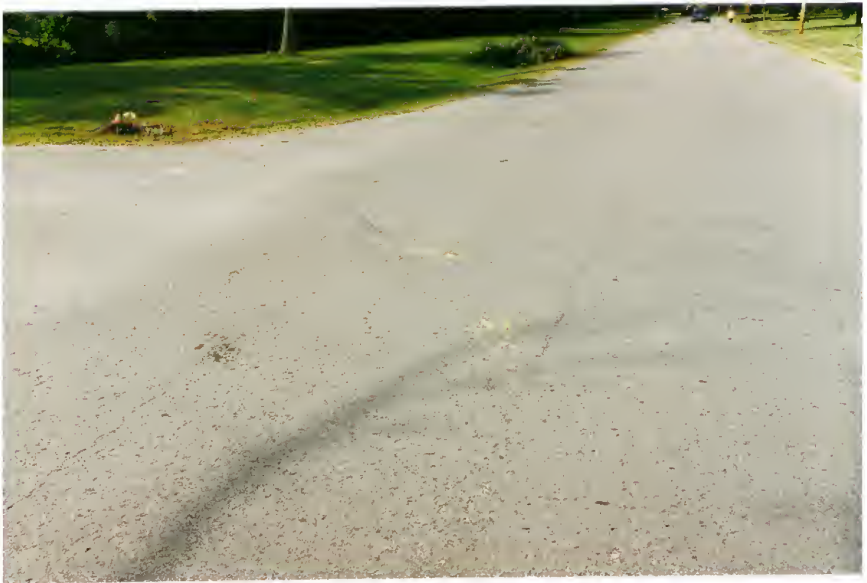
26. View of the post crash trajectory of the Mercury Cougar.

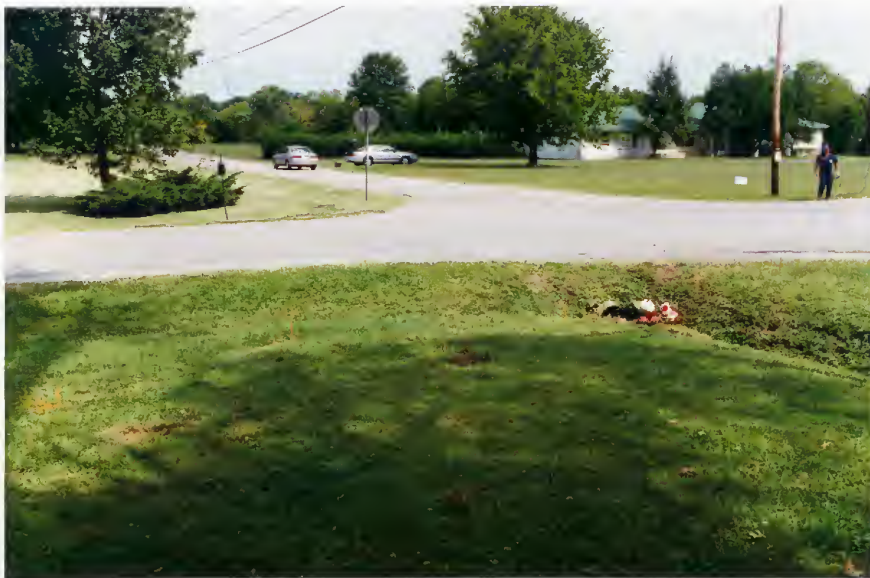
27. Look back view of the from the Mercury Cougar's rest position.

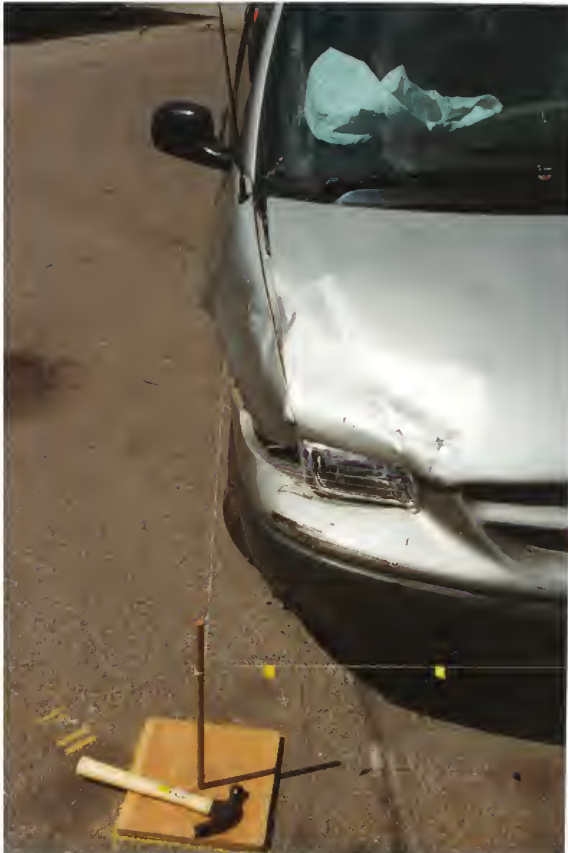
29. Right side longitudinal view.

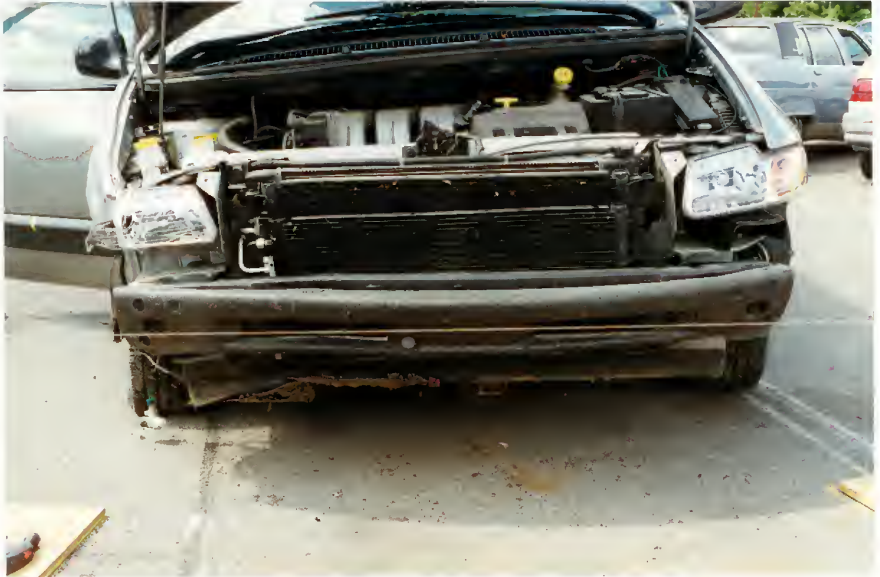
32. Front view of the Dodge Caravan with the bumper fascia removed.

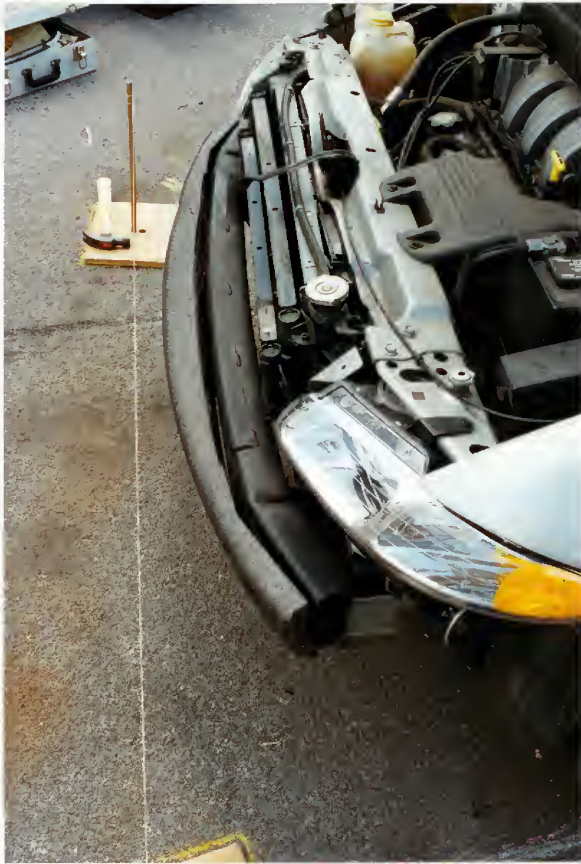
33. Lateral view of the Dodge Caravan bumper reinforcement bar.

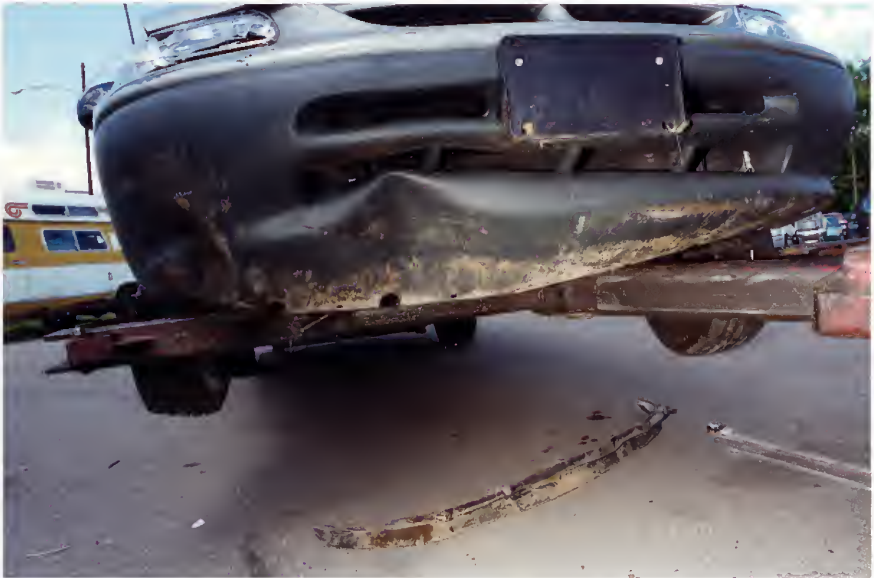
35. Ground view of the right corner of the front bumper fascia.

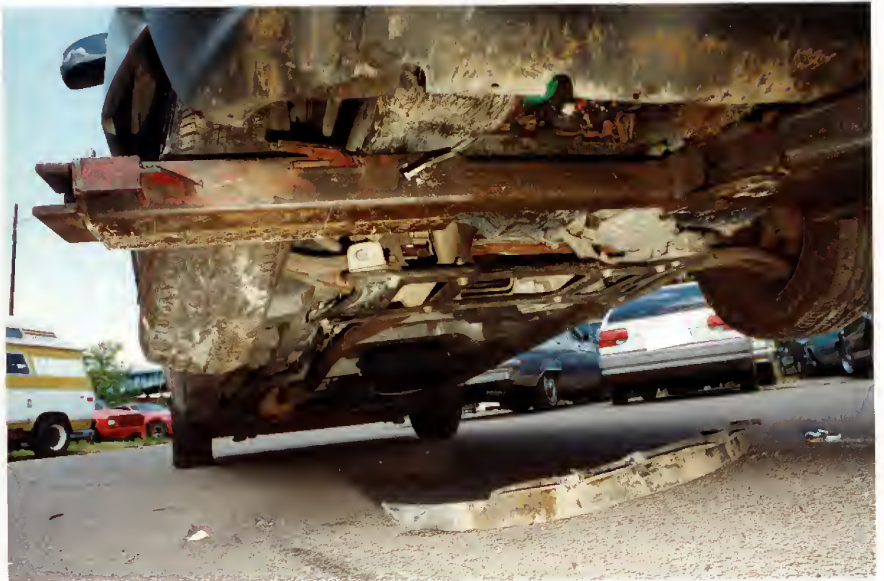
37. View of the forward undercarriage of the Dodge Caravan.

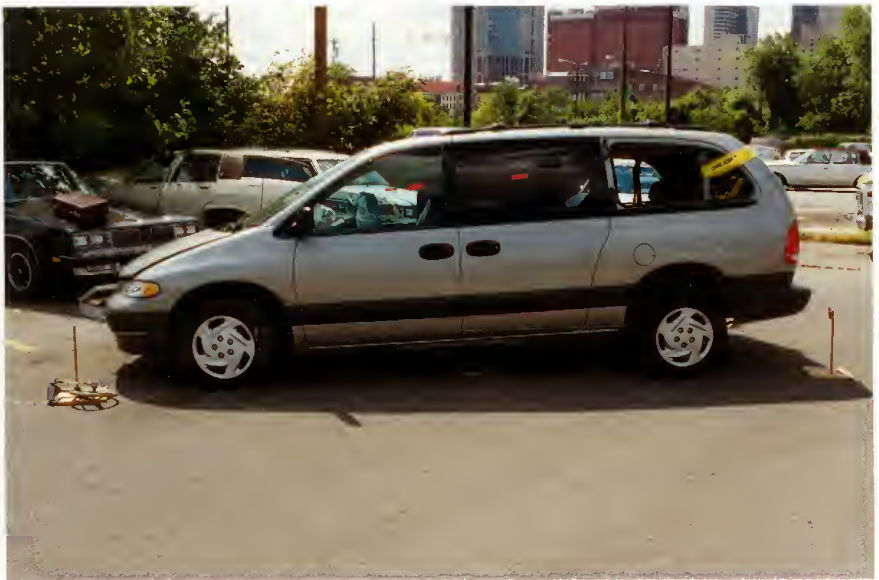
39. Left side view of the Dodge Caravan.

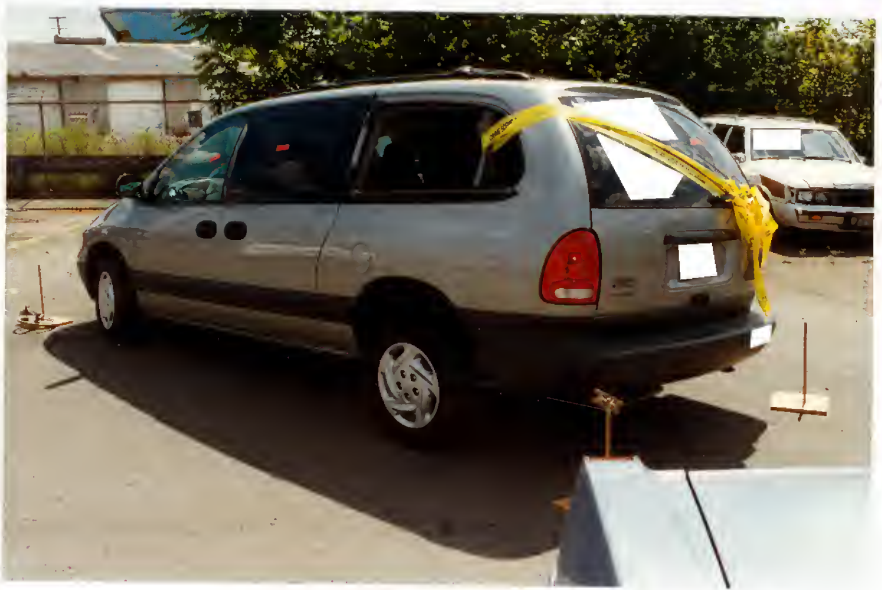
40. Left rear three quarter view.

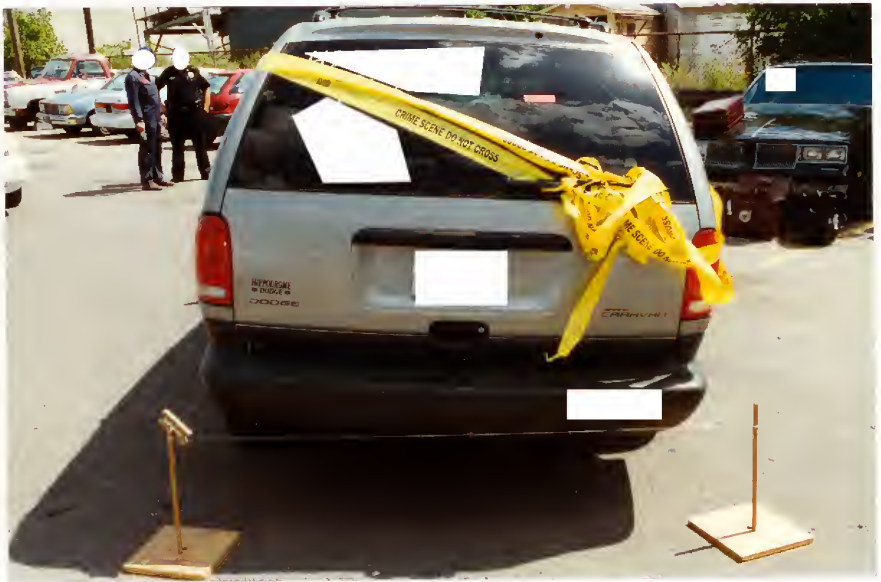
41. Rear view of the Dodge Caravan.

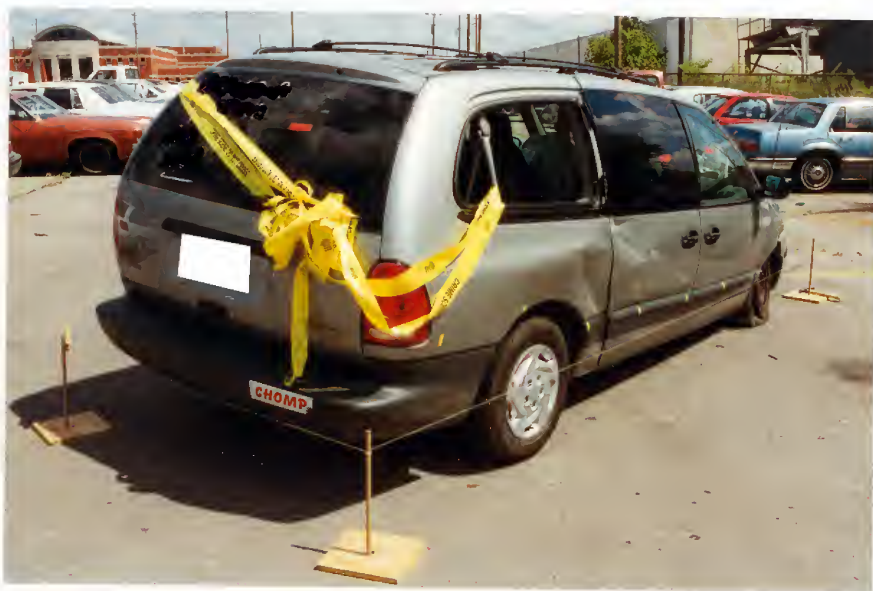
42. Right rear three quarter view.

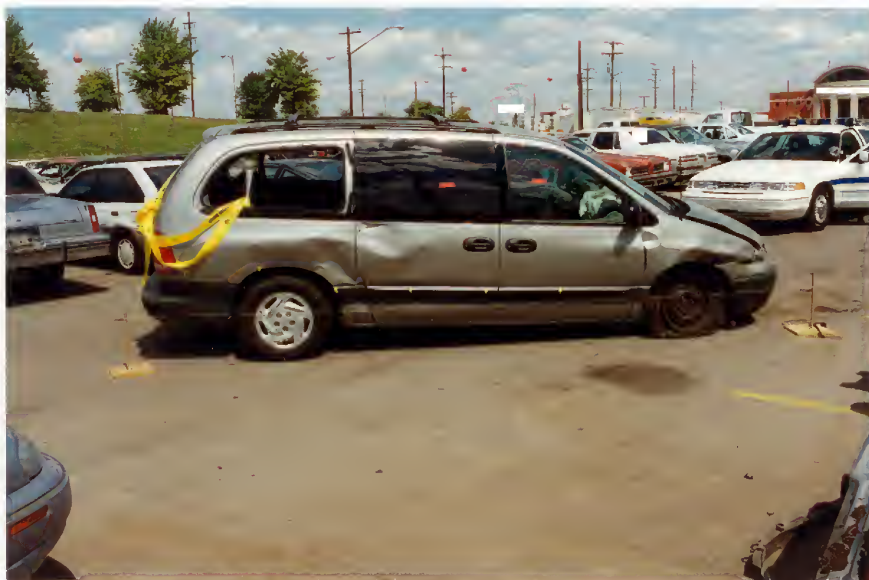
43. Right side view.

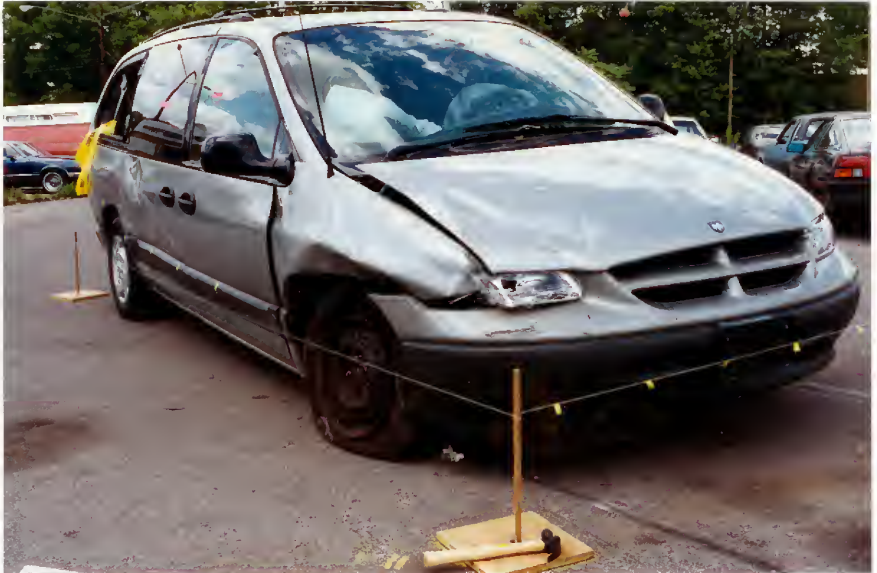
46. Right front three quarter view.

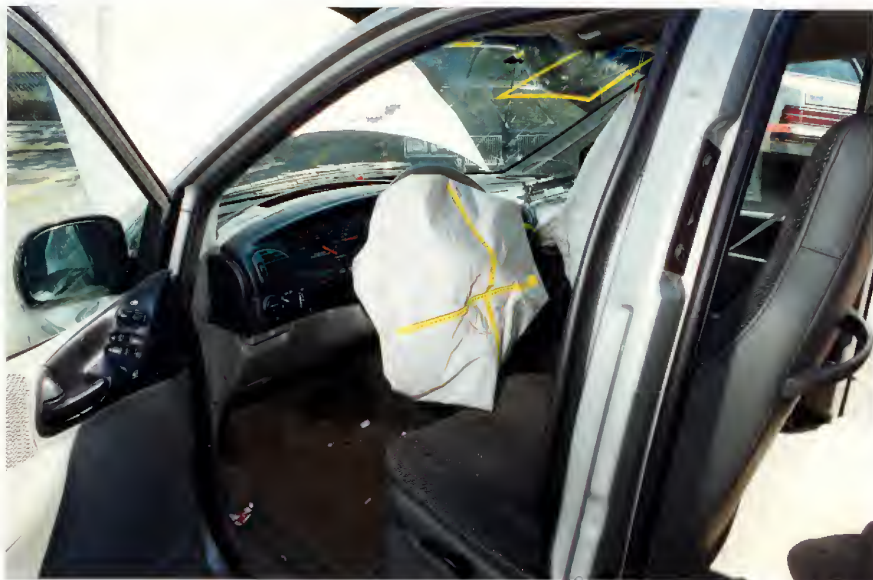
49. Angular view of the driver's compartment.

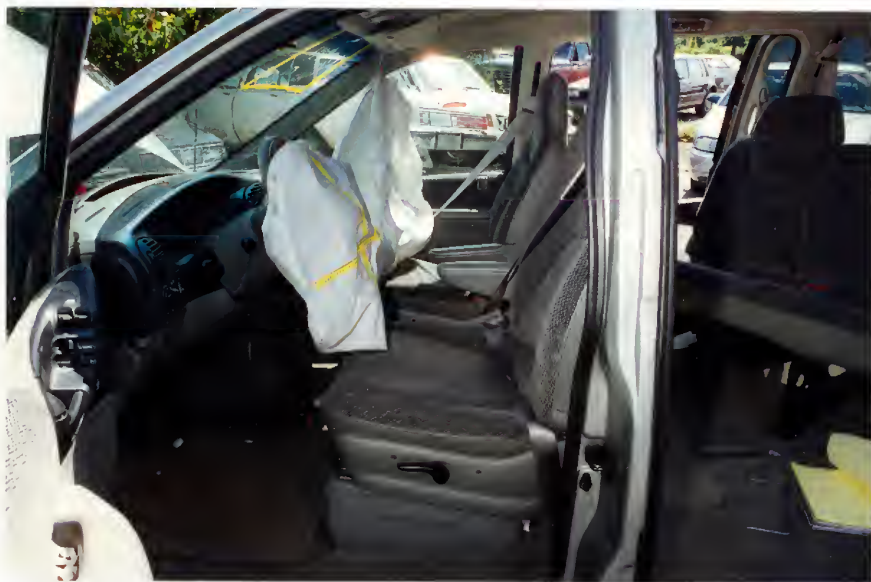
50. Left side view of the front occupant space.

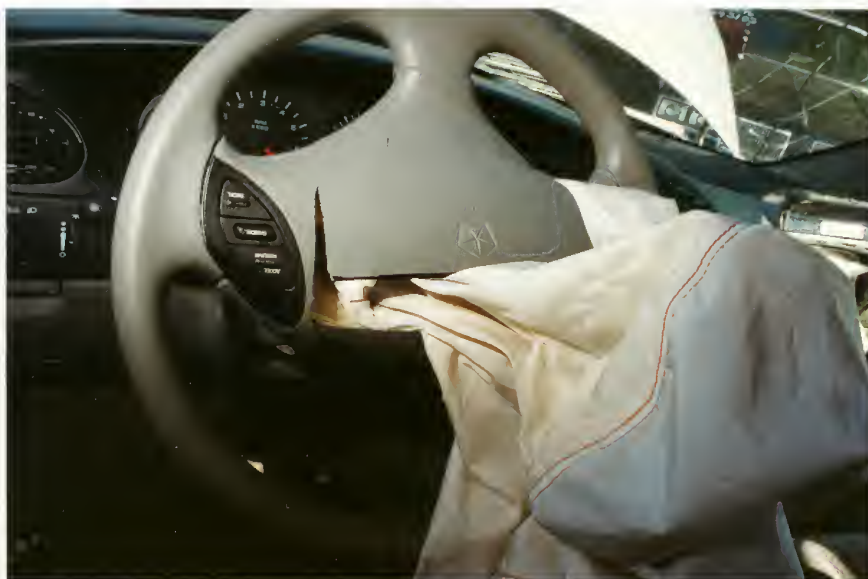
51. View of the steering wheel and the lower module cover flap. Note, the steering wheel is rotated 180 degrees.

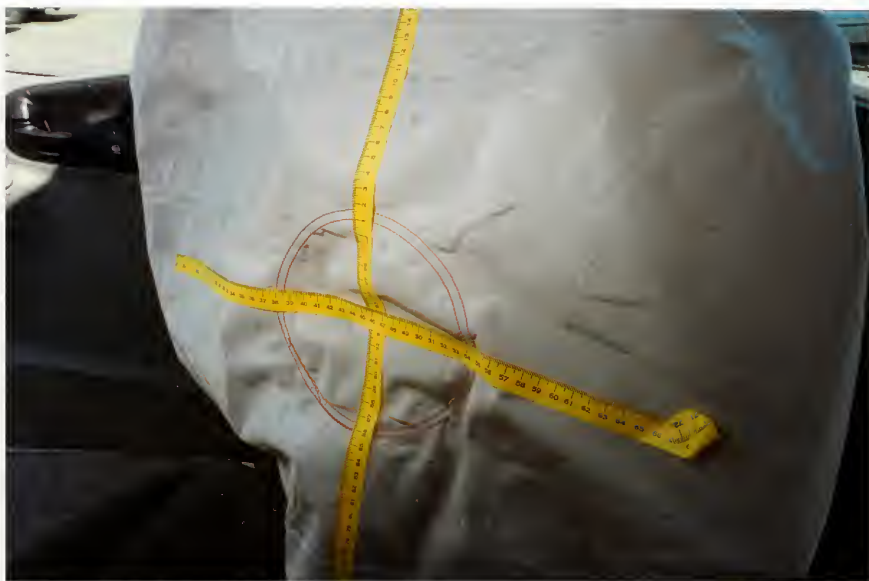
53. Close-up view of blood spatters on the lower left quadrant of the air bag.

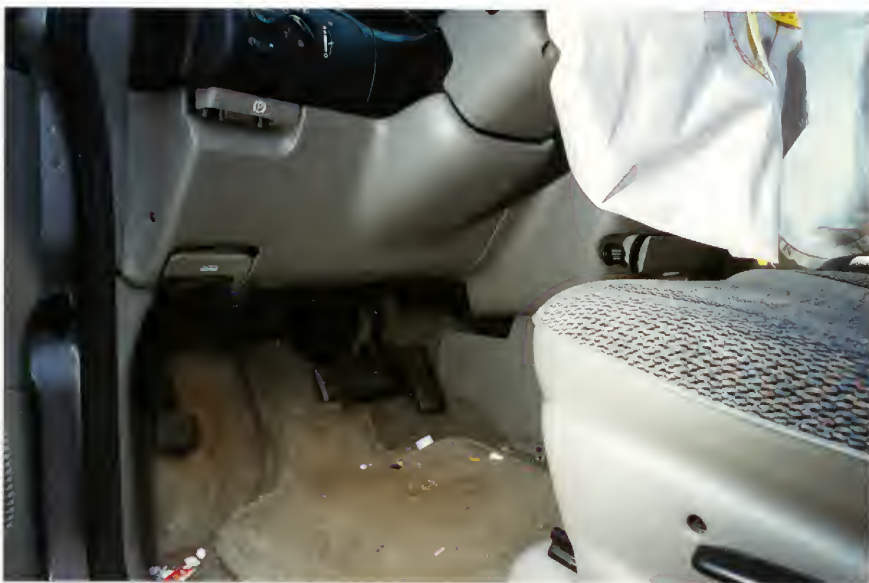
54. View of the driver side knee bolster.

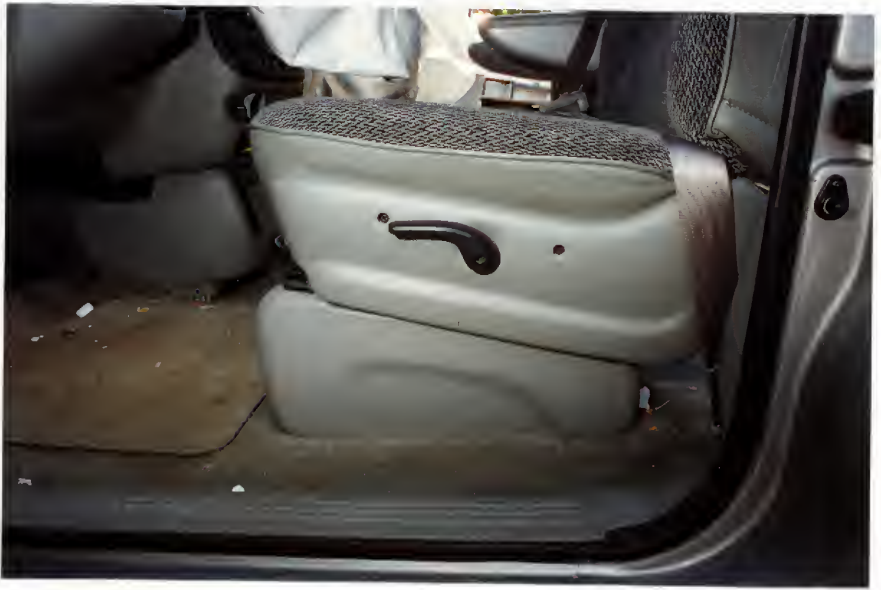
55. View of the driver seat track position.

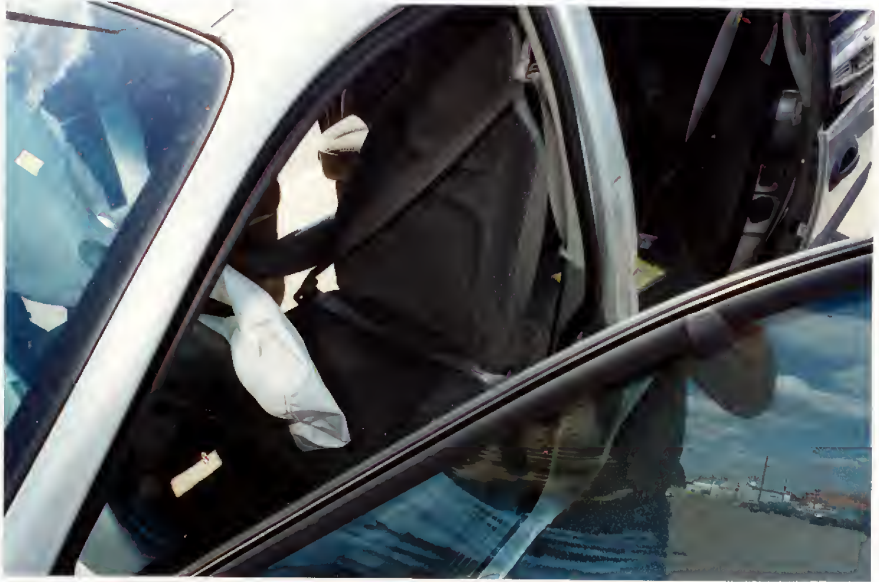
56. Overall view of the driver seat and restraint.

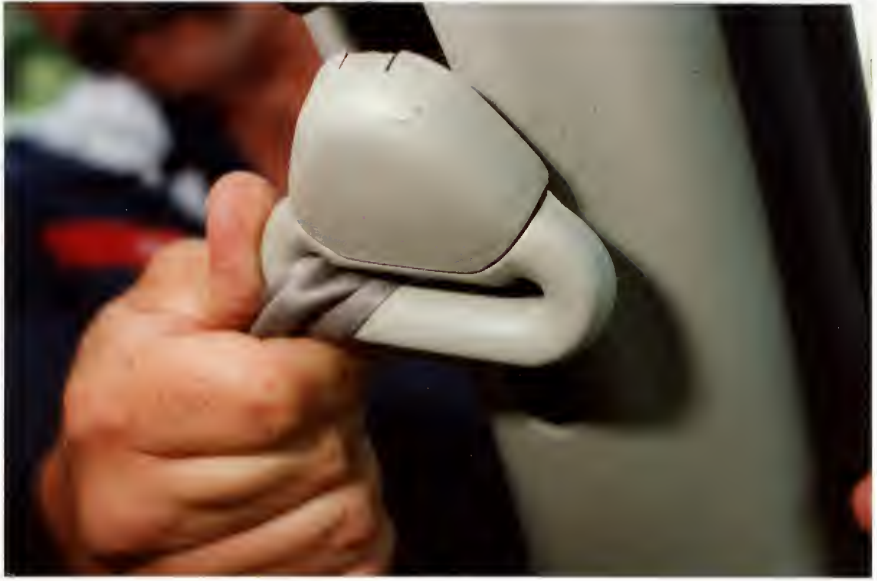
57. Close-up view of the left front D-ring.
